Arizona Center

Project Profile

Location: Phoenix, Arizona

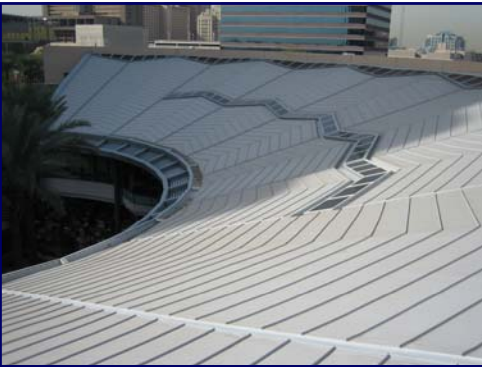
The roof design requires so many joints and seams it is impossible for a metal system to maintain a watertight condition. The roof is a curved elliptical half circle that is further divided into ridges and valleys that create a saw-tooth effect. Interior gutters located in the valleys channel water to the center flat roof where it is removed by interior drains. Five hundred and forty-five linear feet of angled skylights add to the complex design, requiring even more seams.

CQR installed a colored PVC single-ply membrane on top of the existing roof and gutters, creating a monolithic covering. The look of metal was created by welding PVC strips that mimic metal ribs to the membrane.

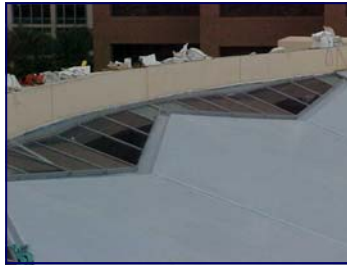
The skylights only extended above the roof one-half inch. Industry standards require a minimum of 8" to allow enough height to properly attach and seal the skylights to the roofing system. It was impractical to raise the skylights because they were mounted to structural beams beneath the 2 1/2" wood deck.
