# Taholah Education Center

## Project Profile

**Location:** Taholah, Washington  
**Owner:** Quinalt Indian Government  
**Use:** Educational  
**Roof Area:** 84,000 square feet  
**Project Completed:** 2004  
**Manufacturer:** Sarnafil  
**Membrane:** G410 Feltback 60 mil Reinforced  
**System:** Fully Adhered

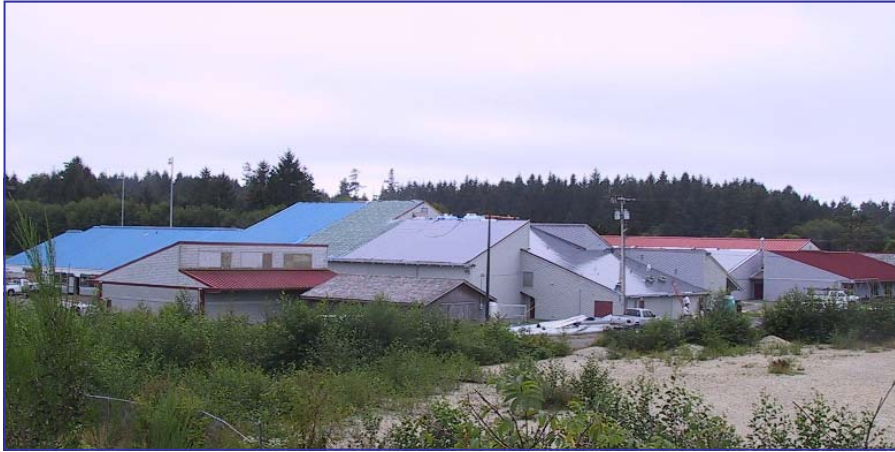
The proximity to the ocean subjected the roof to horizontal torrential rain and wind. The storms descended without visual warning and the frequency of the rain made it impractical to wait for dry weather to work.

The crews worked under tarps during mild rain. Crew leaders monitored the approaching storms using the internet and a laptop computer. They tuned into the National Oceanographers system that uses sonar buoys to warn of approaching storms.

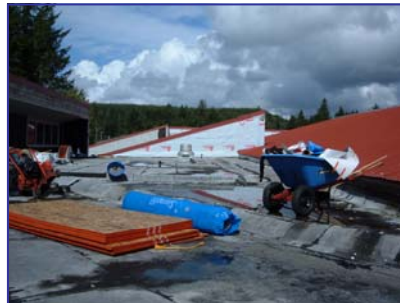
Each roof section had a different type of roof system and architectural design, including flat, low and steep sloped roofs, interior gutters, valleys, interior and exterior edges, skylights and windows.

CQR joined all the different rooftop designs and sections. They replaced the metal roof, the built-up roof, cedar shingles and gutters with a PVC membrane. The metal flashings were replaced with stainless steel laminated with PVC membrane. This created a monolithic, long term maintenance free roof that will handle the weather and the corrosive salt air.

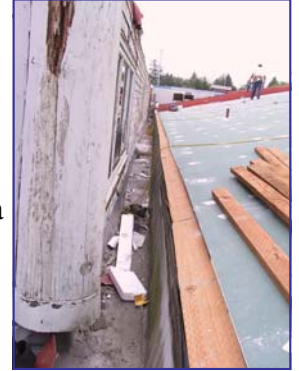
Specifications called for the cedar shingles to be removed and replaced. However, cedar shingles weren't the best choice to keep the complex area watertight.

CQR suggested installing cedar shingles only on the portions of the wall visible from the ground, then installing PVC membrane on the rest of the wall and interior gutters. This formed a seamless system in these areas to stop the perpetual leaking problems.
